JMC Engineering Inc.

December 28, 2021

Reference: STRUCTURAL CONDITION ASSESMENT
Engineering Consulting Services
Crescent Beach Condominium Association, Inc.
100 North Collier Boulevard
Marco Island, FL 34145
JMC Project Number: 123CBC.01

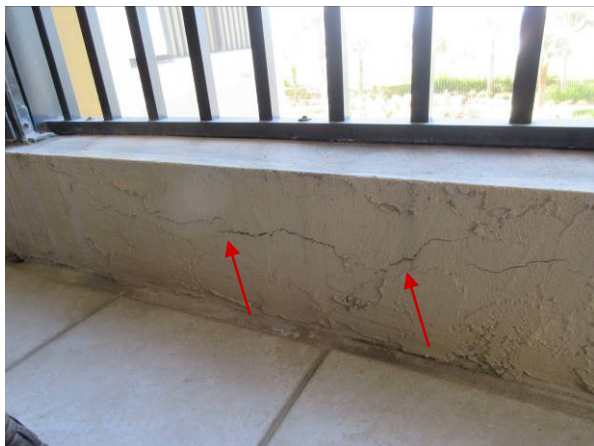
Photo #1 – Unit 208 crack in northeast knee wall.

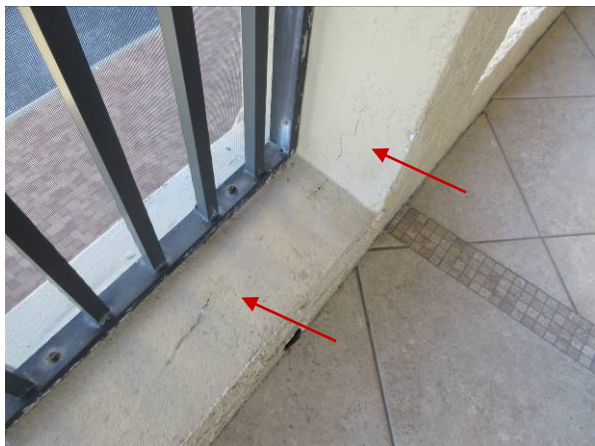
Photo #2 – Unit 308 crack in north knee wall and column.

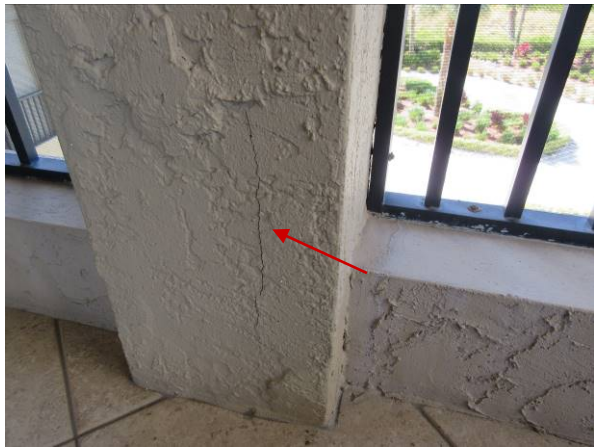
Photo #3 – Unit 308 crack in west column.

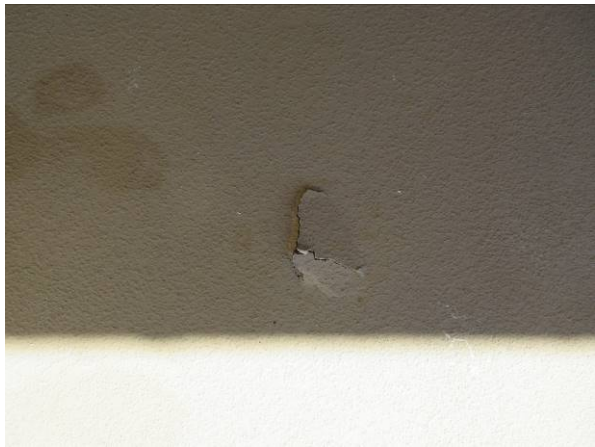
Photo #4 – Unit 604 spalled concrete.

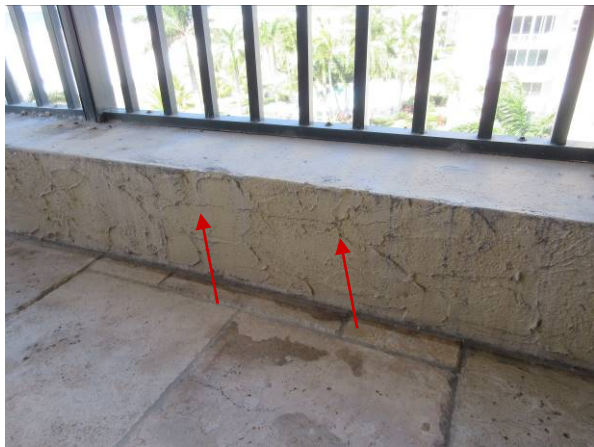
Photo #5 – Unit 608 crack in northeast knee wall.

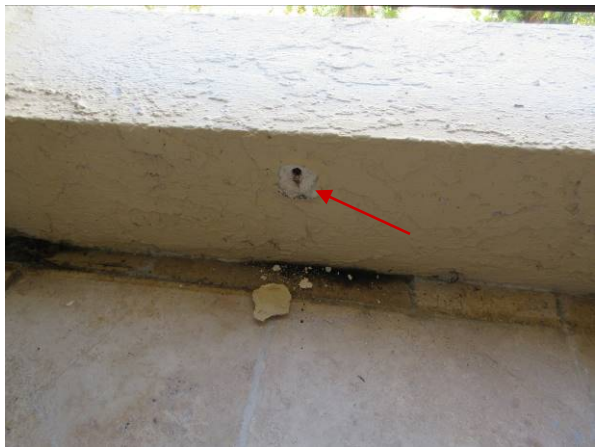
Photo #6 – Unit 608 exposed rust spot on north knee wall.

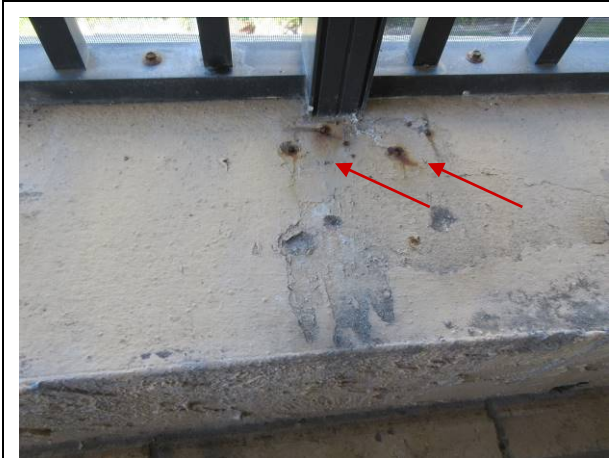
Photo #7 – Unit 608 rusted fasteners from old shutters.

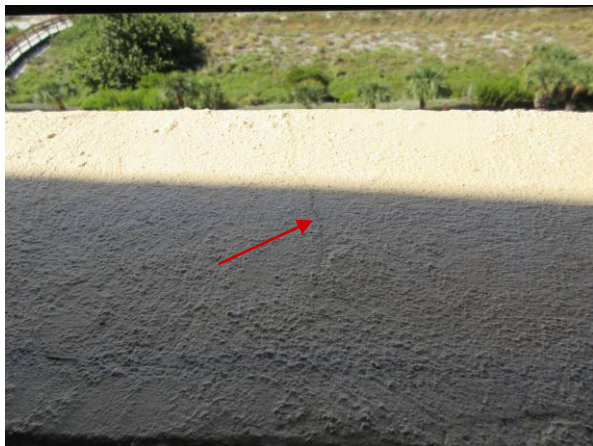
Photo #8 – Unit 702 typical hairline cracks on knee wall.

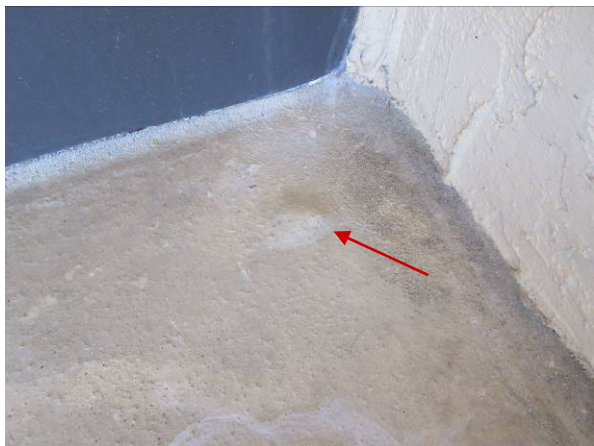
Photo #9 – Unit 801 blister in waterproofing in south corner

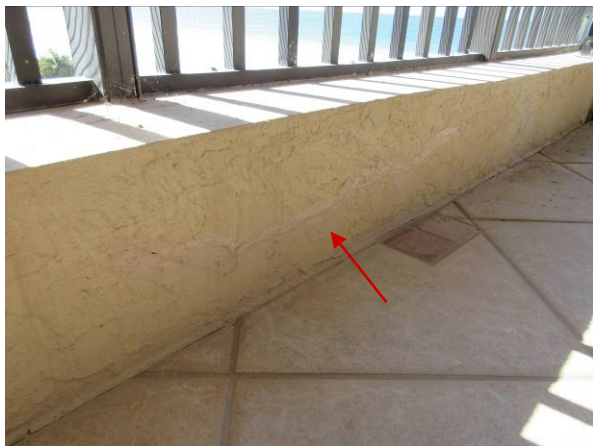
Photo #10 – Unit 800 crack in south knee wall.

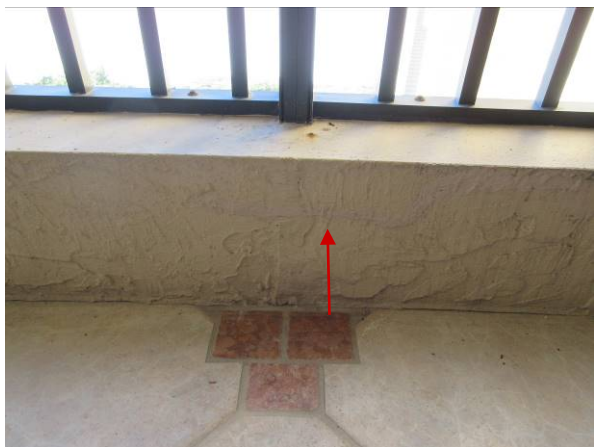
Photo #11 – Unit 800 crack in west knee wall.

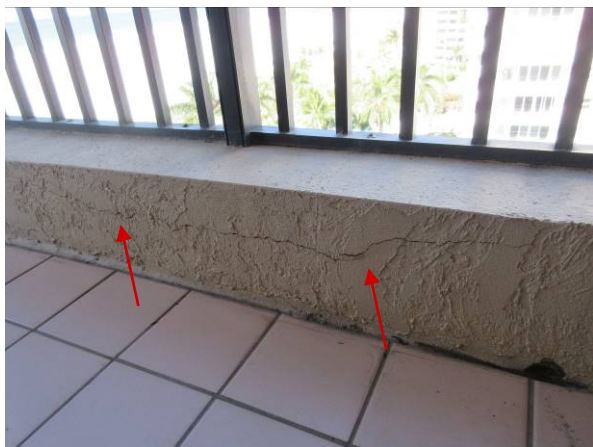
Photo #12 – Unit 908 crack in northwest knee wall

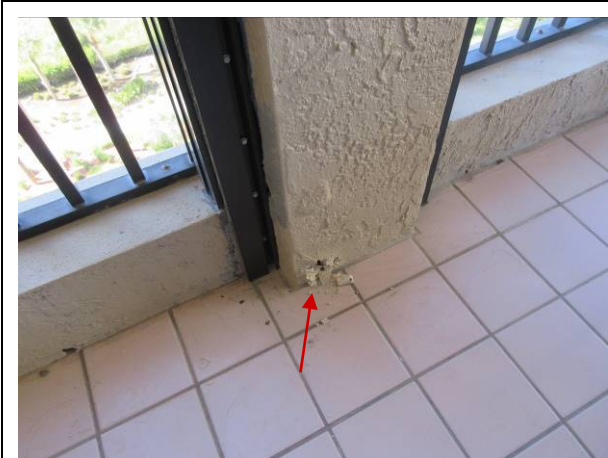
Photo #13 – Unit 908 damage to west column.

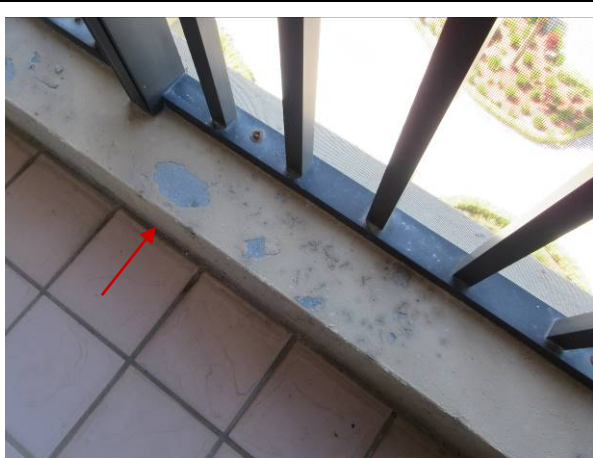
Photo #14 – Unit 908 typical damage to coating on the knee wall.

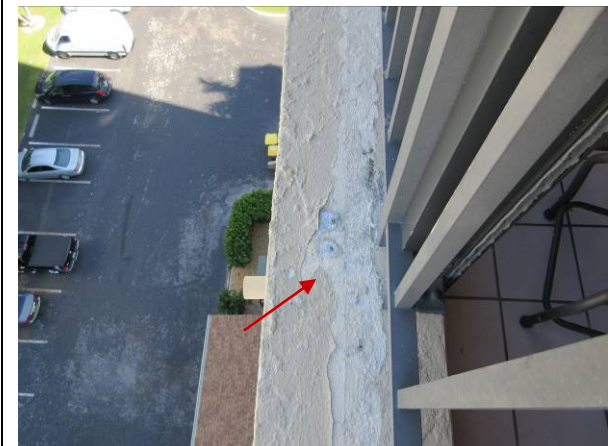
Photo #15 – Unit 908 typical damage to coating on the knee wall.

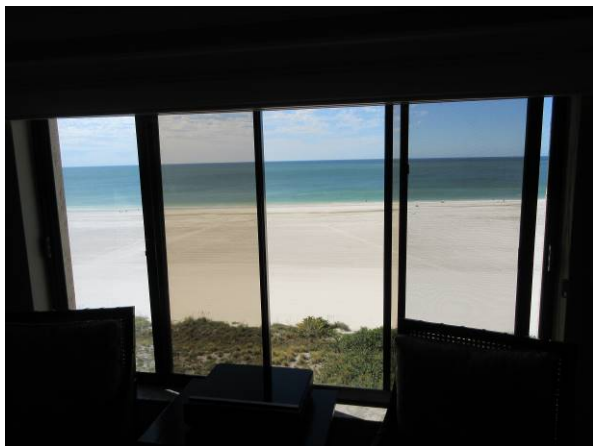
Photo #16 – Unit 1007 master bedroom window.

Separation between the window frame and interior finishes and separation between the window frame and its anchors, such as observed in unit 1007, can be an indication of damage caused by overloading during a previous high wind event. Assemblies that have been damaged by overloading are less likely to survive another high wind event.

- Replacing wind and door assemblies that show indications of previous storm damage, such as the window in unit 1007.
- Replacing non-impacted rated windows and doors with impact rated assemblies so that the classification of the building can be enclosed instead of partially enclosed. Providing protection of openings improves the resiliency of the building and significantly reduces the potential for damage during a high wind event.

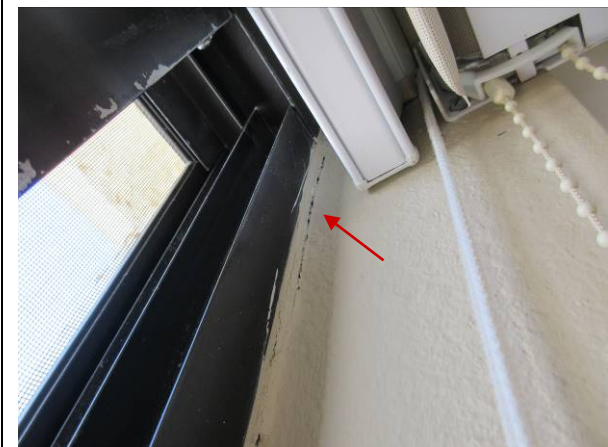
Photo #17 – Unit 1007 master bedroom window frame separation on the right-hand side.

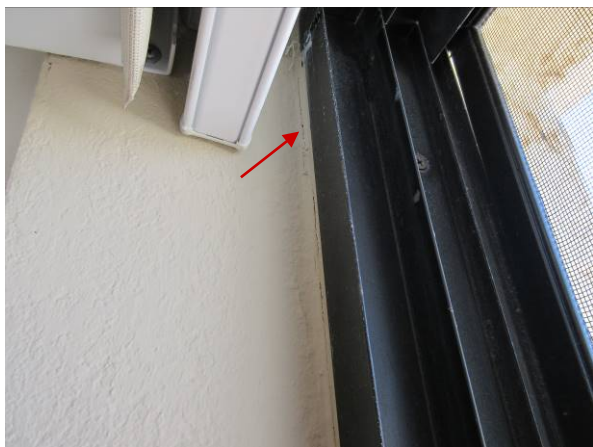
Photo #18 – Unit 1007 master bedroom window frame separation on the left-hand side.

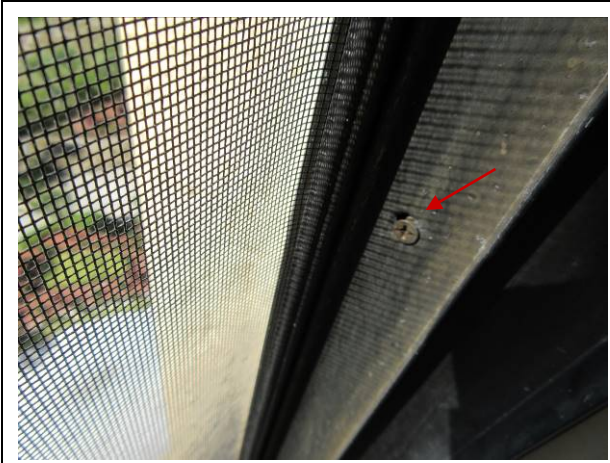
Photo #19 – Unit 1007 master bedroom window evidence of the frame being separated from the anchor.

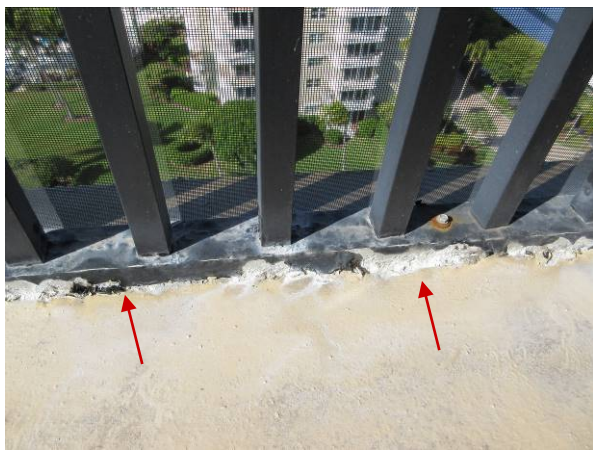
Photo #20 – Unit 1208 damaged aluminum screen enclosure.

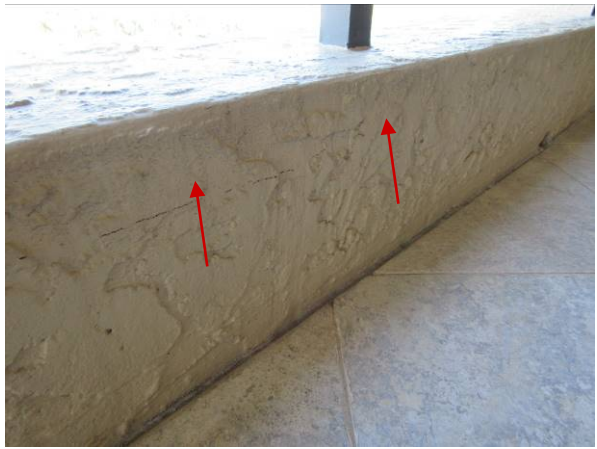
Photo #21 – Unit 1208 crack in north knee wall.

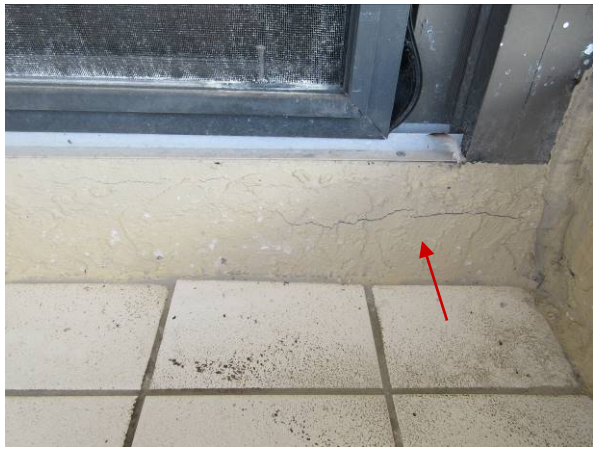
Photo #22 – TH-2 crack in the concrete below the sliding glass door on the 2nd floor.

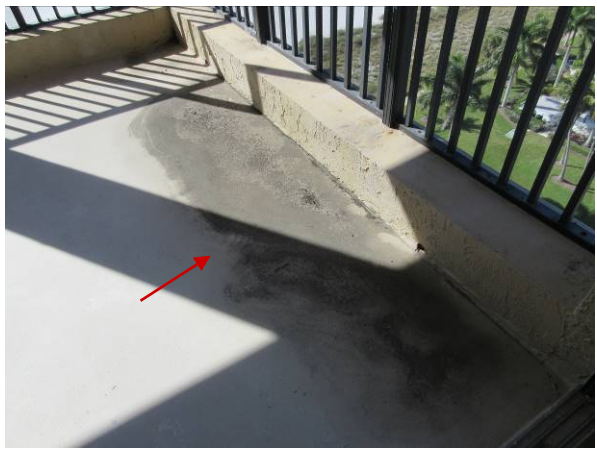
Photo #23 – PH-8 evidence of poor drainage.

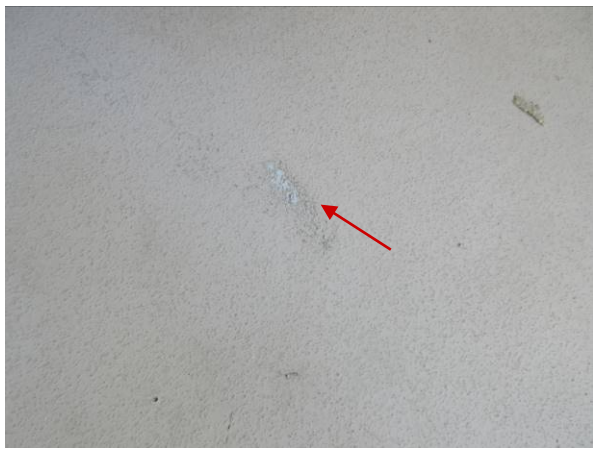
Photo #24 – PH-8 damage to the waterproofing.

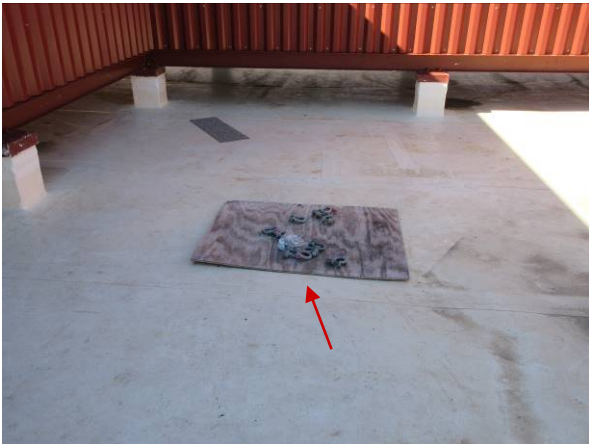
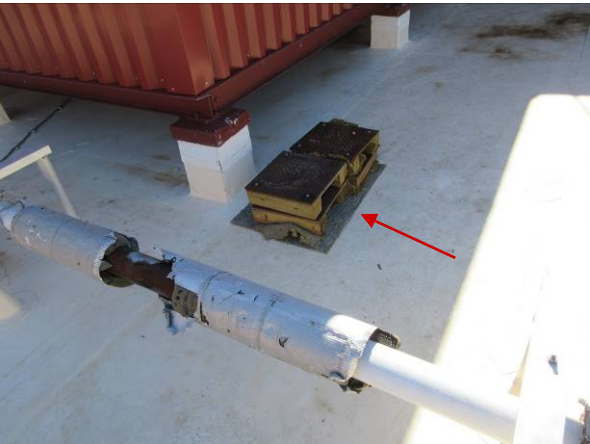
Photo #25 – Roof – typical loose debris.

Photo #26 – Roof – typical loose debris.

The property is in the hurricane-prone region and the wind-borne debris region. Loose materials and debris on the roof and property will become wind-borne during a high wind event and can cause impact damage to the property or its neighbors.

- Securing or removing all the loose material or debris from the roof immediately to reduce the risk of creating wind-borne missiles during a high wind event.

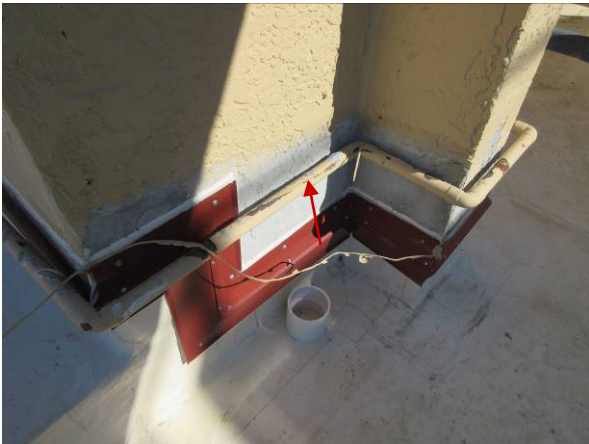
Photo #27 – Roof – typical unpainted stucco repair.

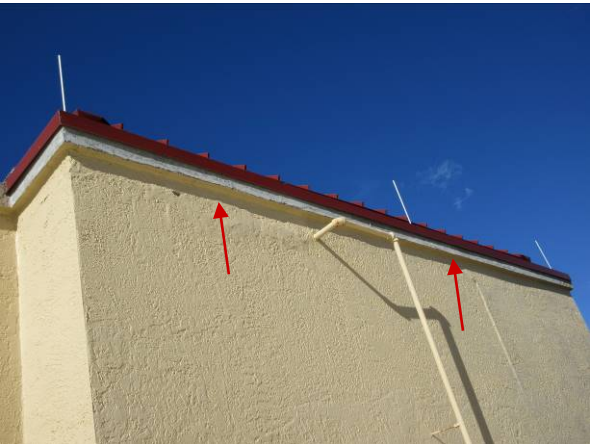
Photo #28 – Roof – typical unpainted stucco repair.

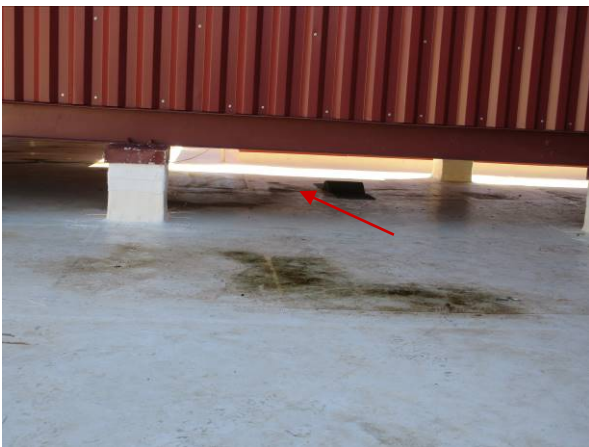
Photo #29 – Roof – Evidence of ponding water.

Ponding water on roofs can lead to dirt accumulation and vegetation growth, algae growth, premature failure of the roof system, and in extreme cases, structural overload.

- Inspecting the roof regularly. Inspections should be performed twice a year and after storm events at a minimum. Periodically clean the roof of accumulated dirt and algae growth with methods acceptable to the membrane manufacturer.

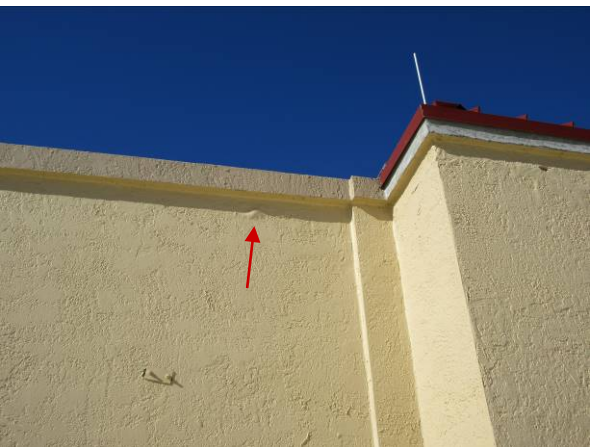
Photo #30 – Roof – blister in paint.

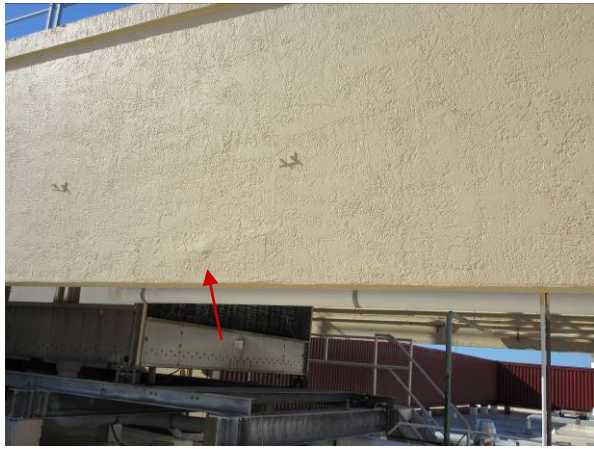
Photo #31 – Roof – blister in paint.

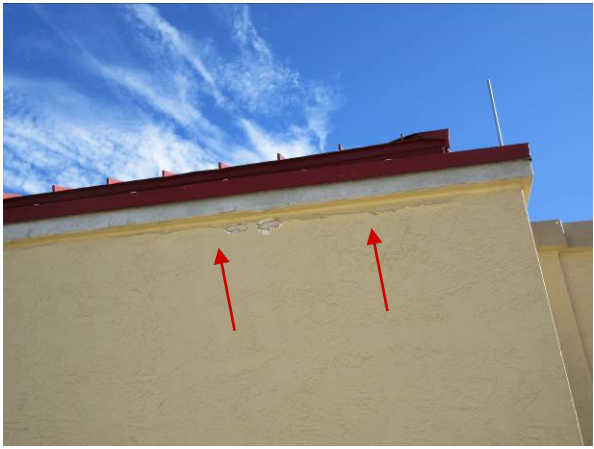
Photo #32 – Roof – cracked stucco on the elevator tower.

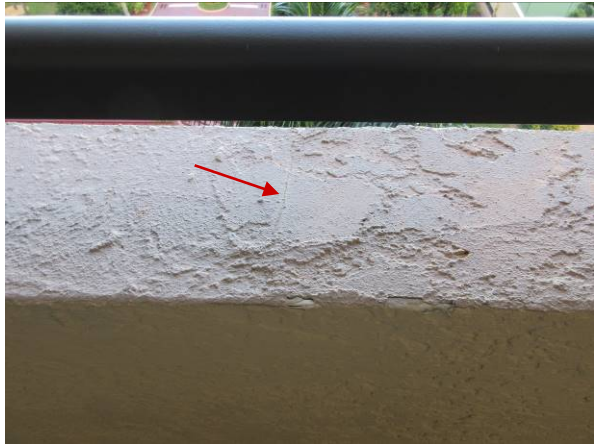
Photo #33 – Exterior walkways – typical hairline cracks on the knee walls.

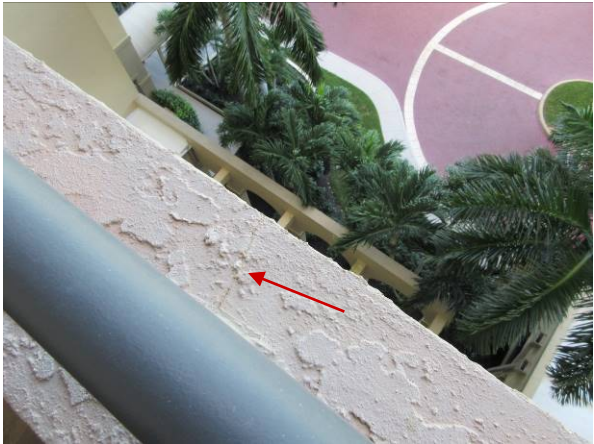
Photo #34 – Exterior walkways – typical hairline cracks on the knee walls.

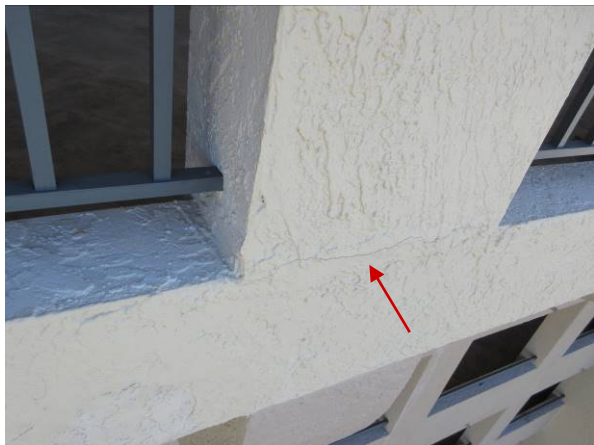
Photo #35 – Exterior walkways – typical hairline cracks in the stucco.

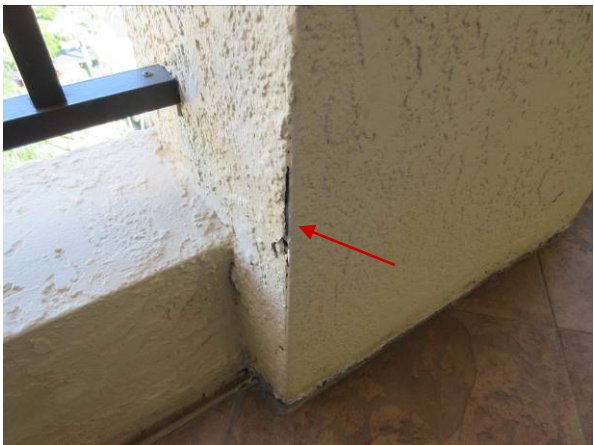
Photo #36 – Exterior walkways – damaged stucco on column south end on PH level.

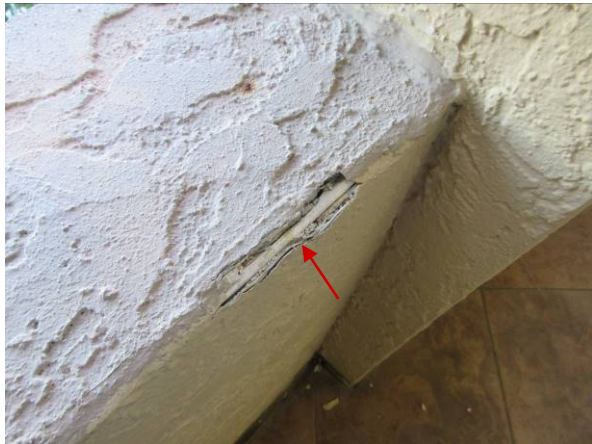
Photo #37 – Exterior walkways – damaged stucco in front of unit 703.

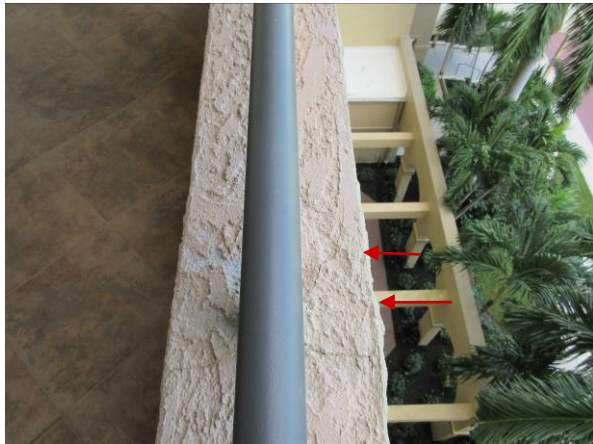
Photo #38 – Exterior walkways – potential concrete damage in front of unit 605.

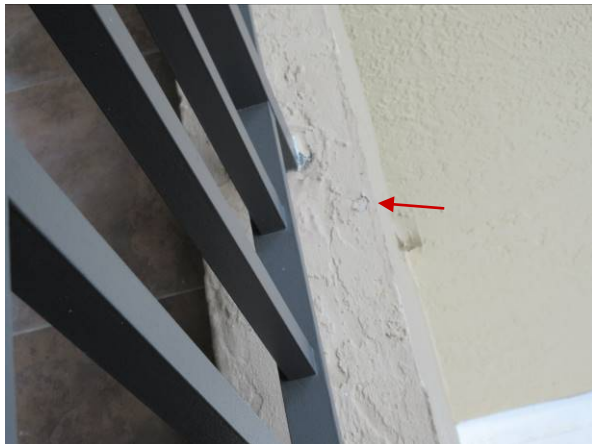
Photo #39 – Exterior Walkways – peeling paint on knee wall on balcony near elevators.

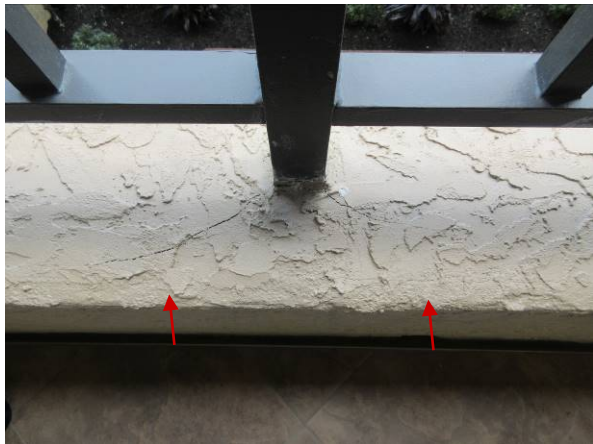
Photo #40 – Exterior walkways – potential concrete damage in front of unit 206.

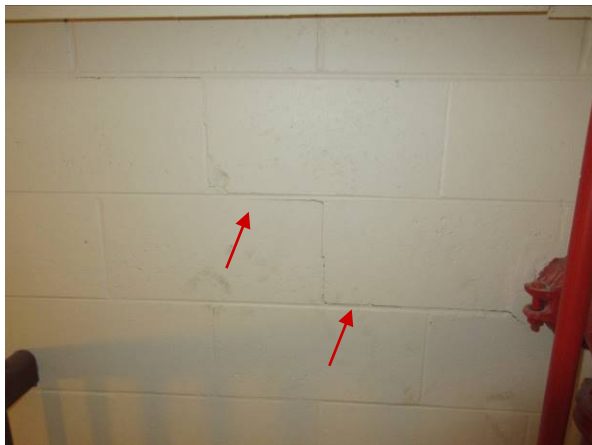
Photo #41 – South stairwell – stairstep crack on the roof level.

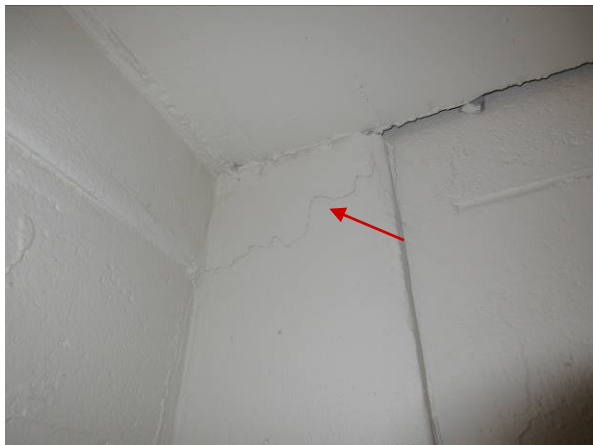
Photo #42 – North stairwell – potential concrete damage on the column between the 10th and 11th floor.

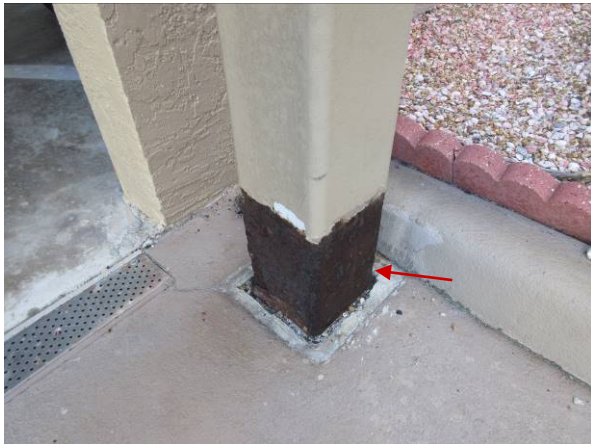
Photo #43 – Front awnings – typical base posts are rusted.

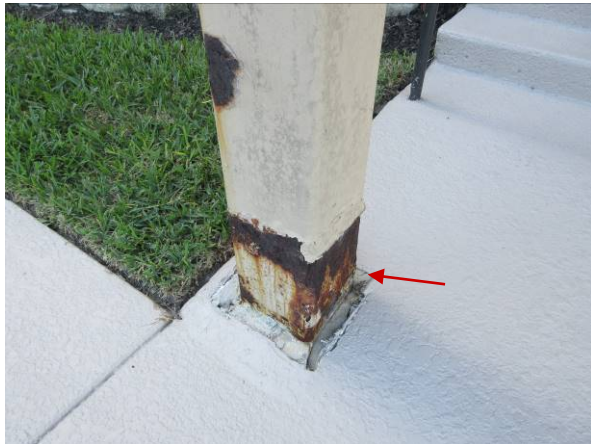
Photo #44 – Front awnings – typical base posts are rusted.

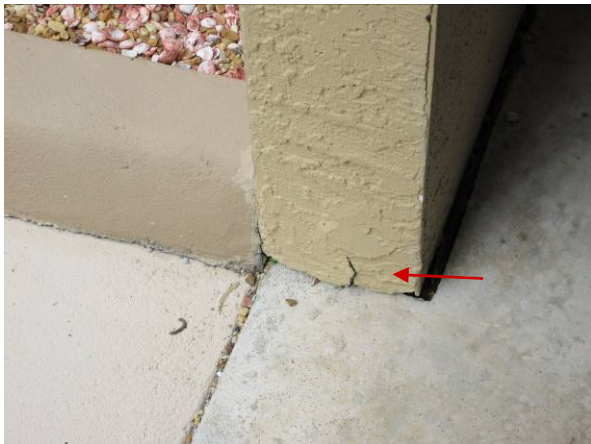
Photo #45 – North garage – crack in stucco at west entrance.

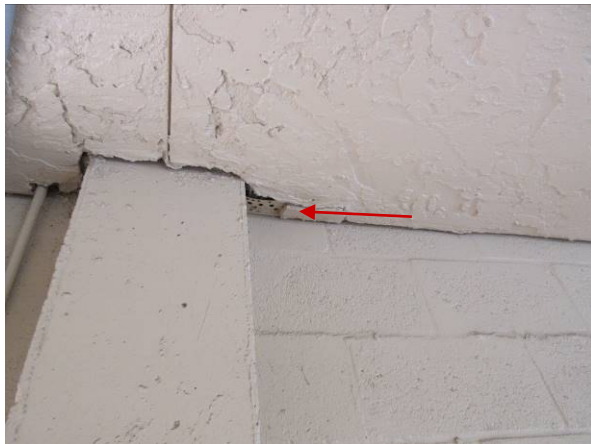
Photo #46 – North garage – damaged stucco near west entrance

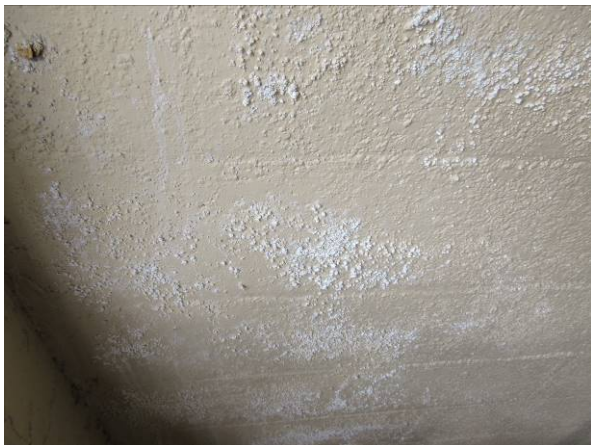
Photo #47 – North garage – evidence of efflorescence on the wall near the west entrance.

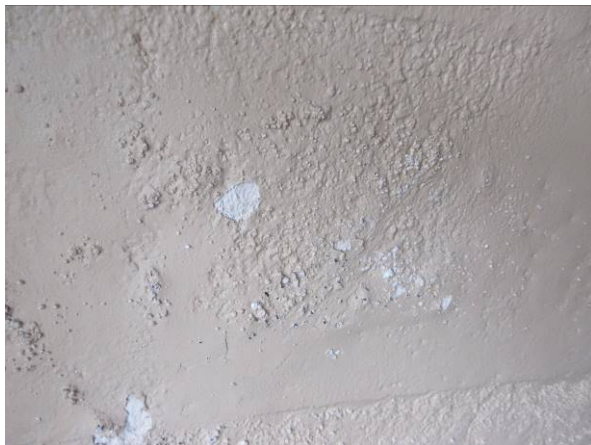
Photo #48 – North garage - evidence of peeling paint on the wall near the west entrance.

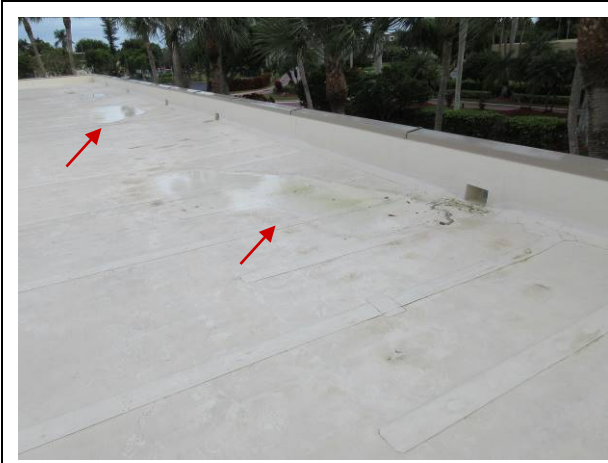
Photo #49 – North garage – evidence of ponding water.

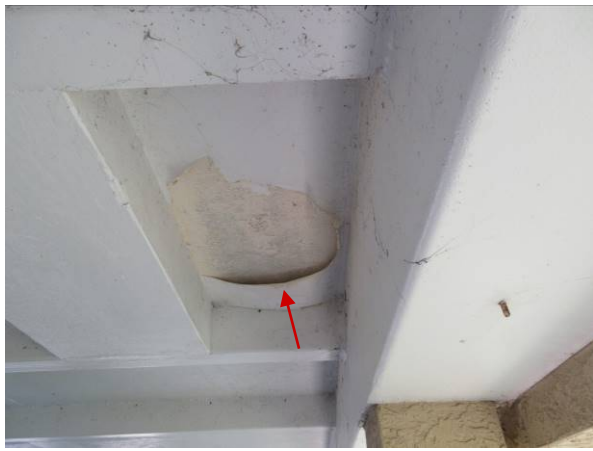
Photo #50 – South garage – peeling paint near the west entrance.

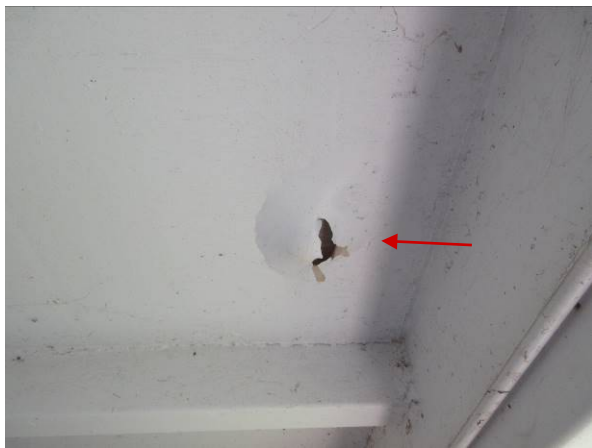
Photo #51 – South garage – blister full of water on the southeast corner.

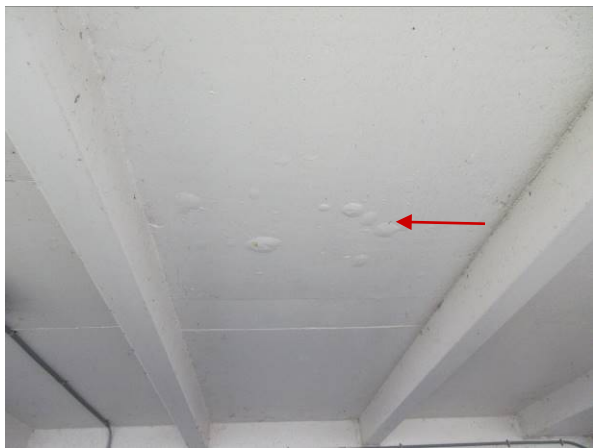
Photo #52 – South garage – blisters in paint on the south end.

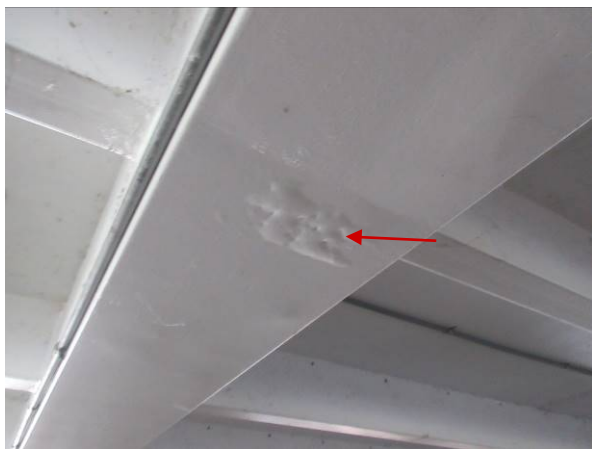
Photo #53 – South garage – blisters in paint on the south end.

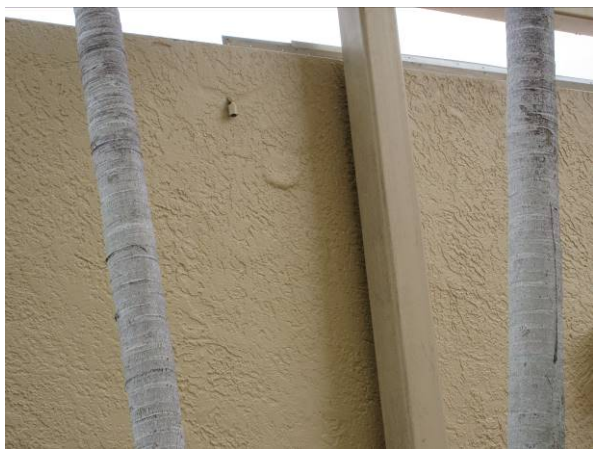
Photo #54 – South garage – blisters in paint near west entrance.

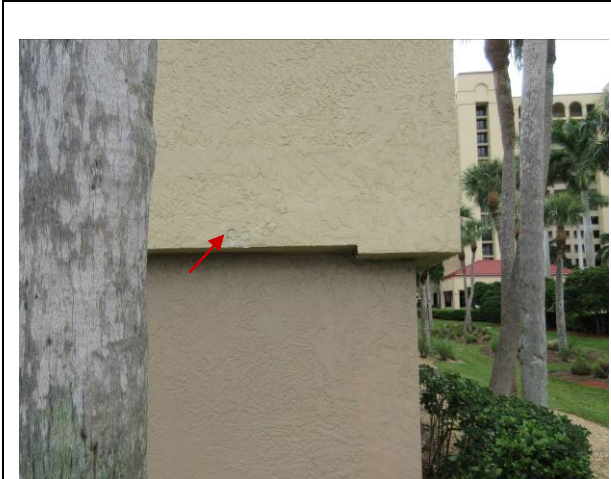
Photo #55 – South garage – peeling paint on the east end.

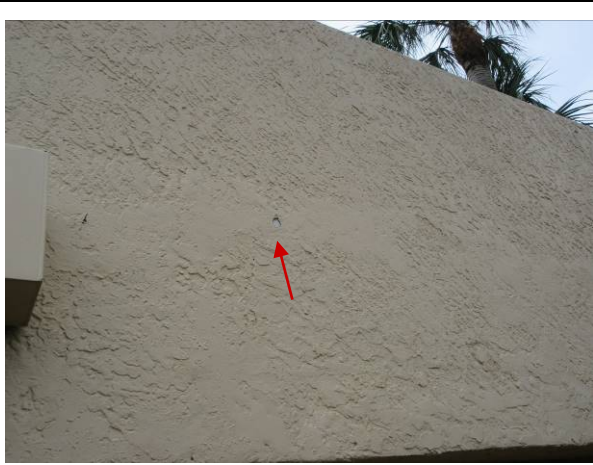
Photo #56 – South garage – hole in the stucco near the east entrance.

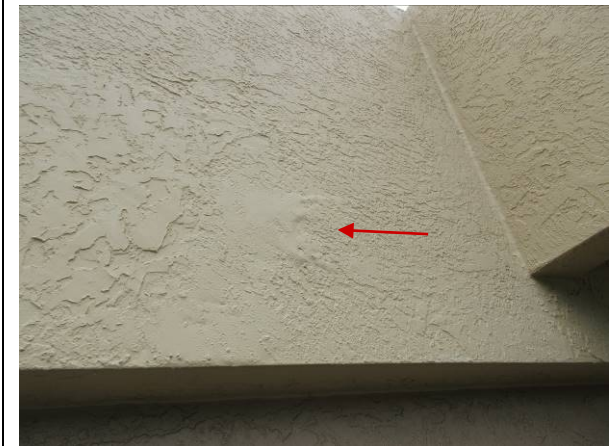
Photo #57 – South garage – blisters in the paint near the east entrance.

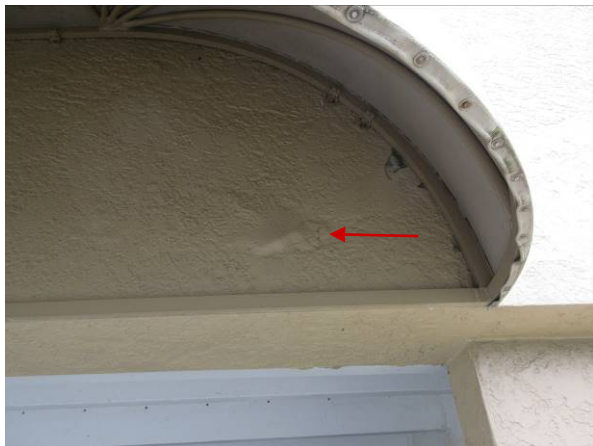
Photo #58 – South garage – blisters in the paint near the east entrance.

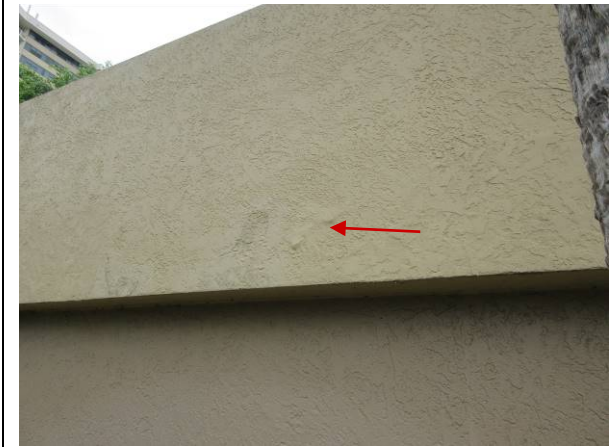
Photo #59 – South garage – blisters in paint on the southeast corner.

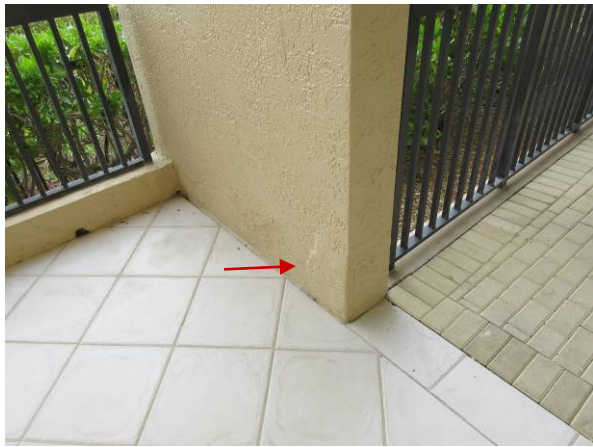
Photo #60 – Rear of tower – potential damaged concrete at base of the column outside common area entrance.

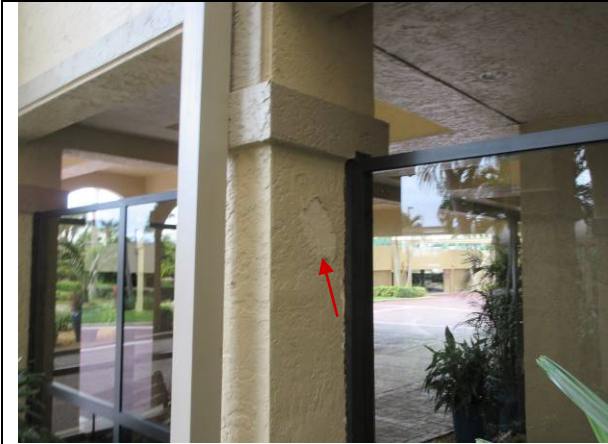
Photo #61 – Front of tower – peeling paint on column.

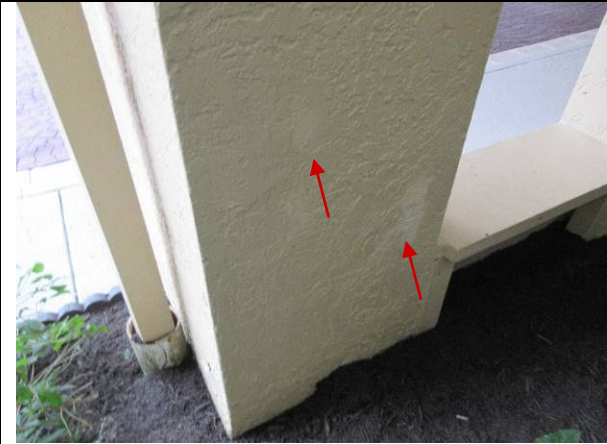
Photo #62 – Front of tower – peeling paint on column.

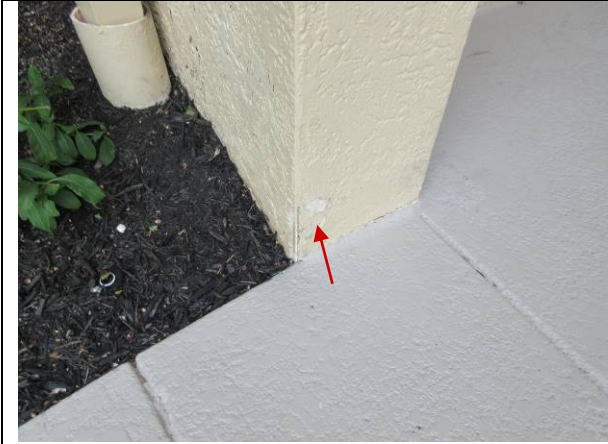
Photo #63 – Front of tower – peeling paint on pillar.

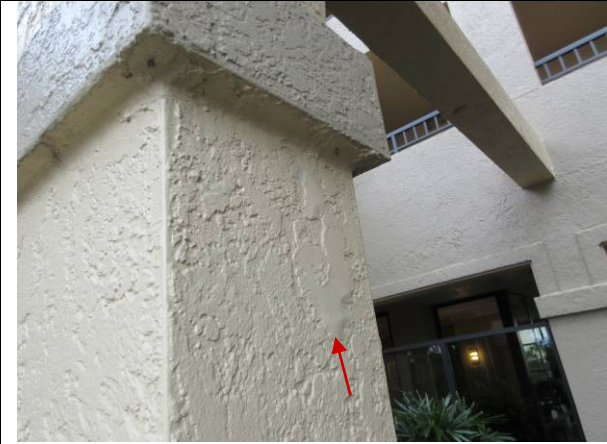
Photo #64 – Front of tower – blister in paint on pillar.

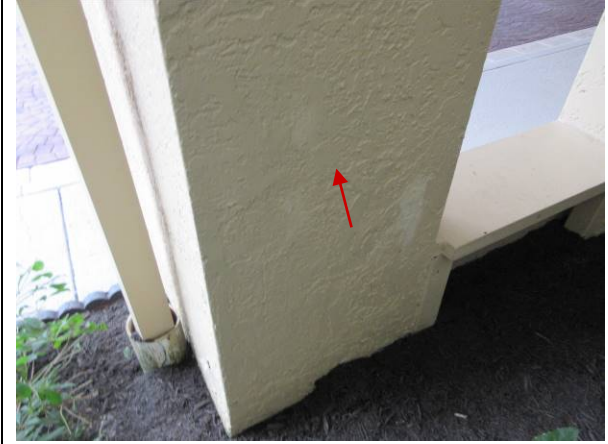
Photo #65 – Front of tower – blister in paint on pillar.

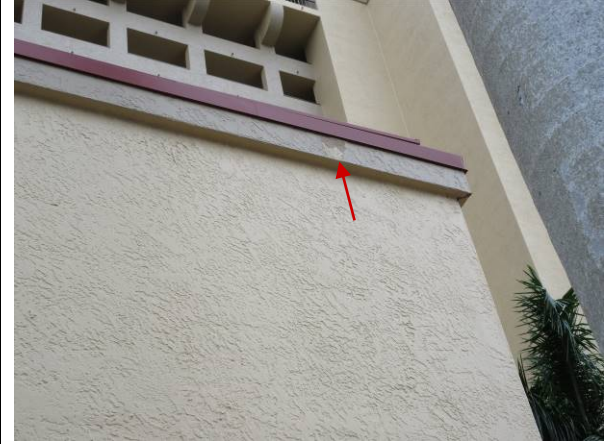
Photo #66 – Front of tower – peeling paint on trim band.
