Uniform Mitigation Verification Inspection Form

Inspection Date: 04/23/2021		
Owner Information		
Owner Name: S. FRANZESE		Contact Person: Sheila
Address: 100 N Collier Blvd #706		Home Phone:
City: Marco Island	Zip: 34145	Work Phone:
County: COLLIER		Cell Phone: 401-474-1301
Insurance Company:		Policy #:
Year of Home: 1990	# of Stories: 14	Email:

S. Franzese: 100 N Collier Blvd #706 Marco Island built 1990

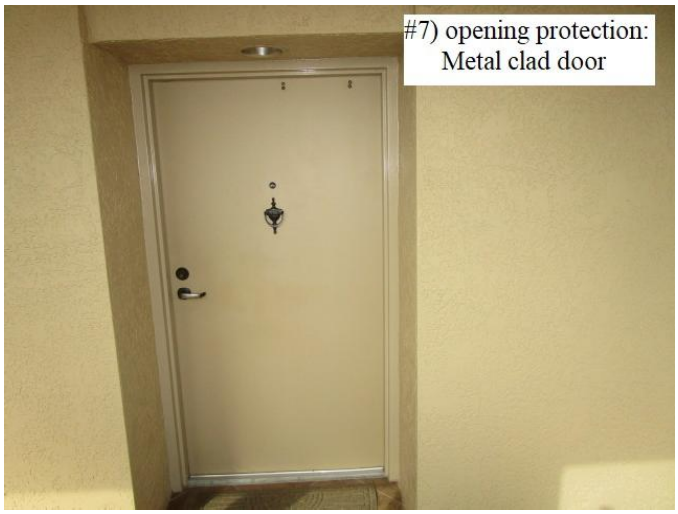
#7) opening protection:
Metal clad door

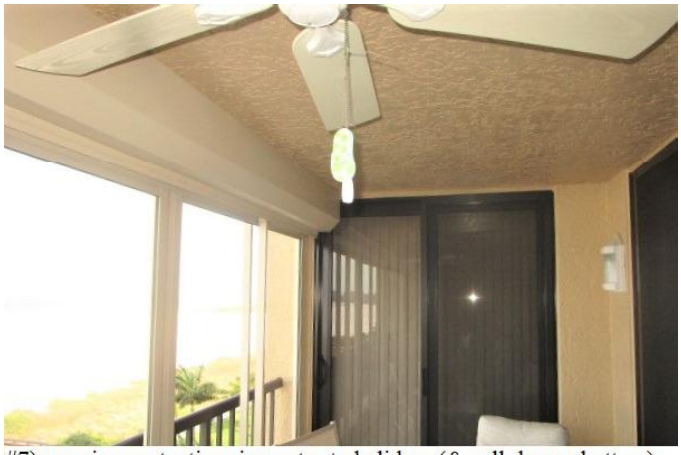
#7) opening protection: impact rated sliders (& roll down shutters)
permit WD-17-09469 applied 12/14/2017

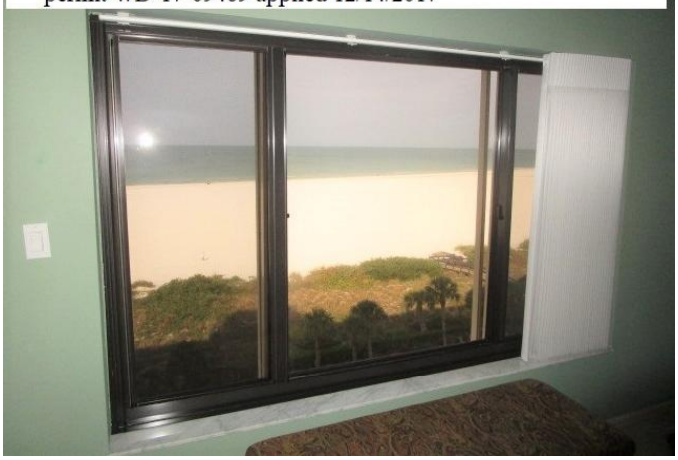
#7) opening protection: impact rated windows
permit WD-17-09469 applied 12/14/2017

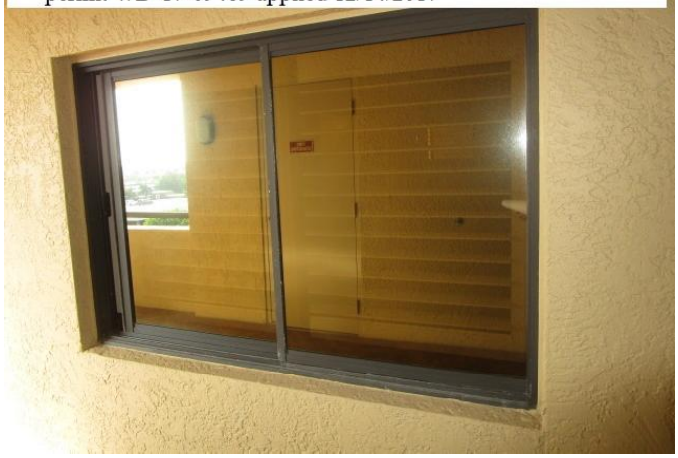
#7) opening protection: impact rated windows & sliders
permit WD-17-09469 applied 12/14/2017
mfg watermark- MDCA= mia-dade county approved
