Uniform Mitigation Verification Inspection Form

Inspection Date: 06/30/2021		
Owner Information		
Owner Name: S. VARSANO		Contact Person: Sam
Address: 100 N. Collier #708		Home Phone:
City: Marco Island	Zip: 34145	Work Phone:
County: COLLIER		Cell Phone: 239-970-0020
Insurance Company:		Policy #:
Year of Home: 1990	# of Stories: 14	Email:

S. Varsano: 100 N. Collier #708 Marco Island built 1990

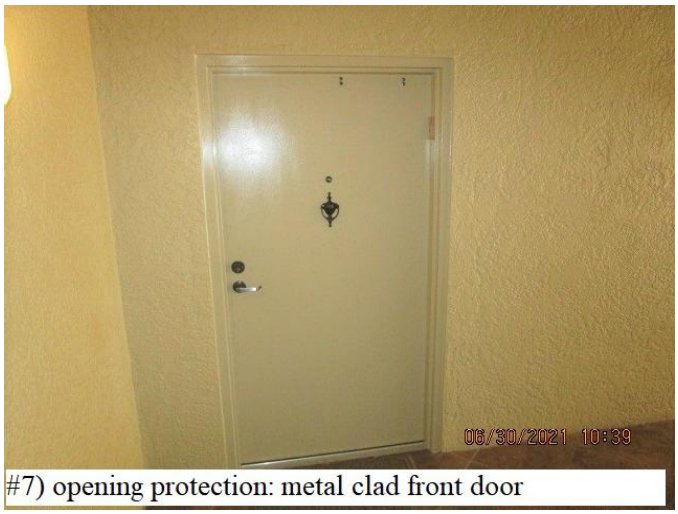
#7) opening protection: metal clad front door
