Uniform Mitigation Verification Inspection Form

Inspection Date: 04/23/2021		
Owner Information		
Owner Name: M. SCHULZ		Contact Person: Marsha
Address: 100 N Collier Blvd #1107		Home Phone:
City: Marco Island	Zip: 34145	Work Phone:
County: COLLIER		Cell Phone: 239-970-0385
Insurance Company:		Policy #:
Year of Home: 1990	# of Stories: 14	Email:

M. Schulz 100 N Collier Blvd #1107 Marco Island built 1990

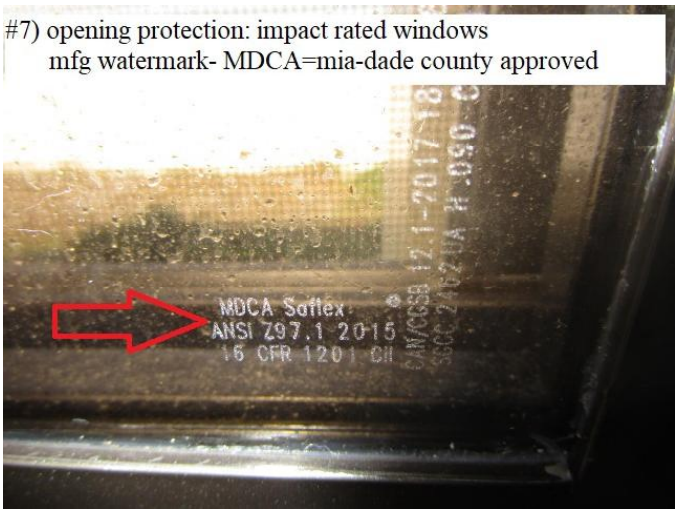
#7) opening protection: impact rated windows
